# Manhole Inspection Summary

Manhole # S53C\_\_055MH

Insp Date: **6/13/08 11:17 AM**

**Location** Address: **3210 e fayette st**

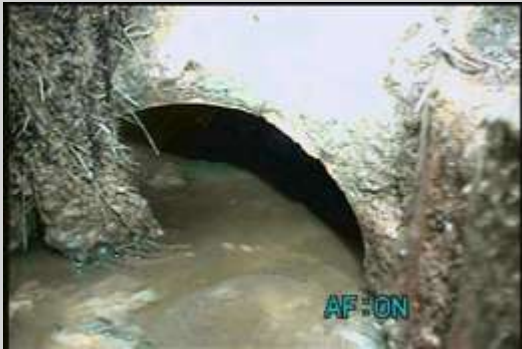
12 O'Clock Outflow

6 in. Circular Gravity Sewer  
Pipe Out @ 12 O'Clock

Invert Depth: 3.62 (ft.) Flow Characteristics: **Slow**

Deposits: ☒ None ☐ Mud ☐ Sludge ☐ Debris ☐ Grease

Infiltration: **None** Pipe Seal Cond: **Unknown**

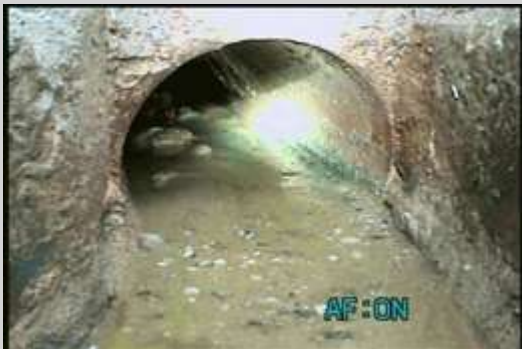
3 O'Clock Inflow

6 in. Circular Gravity Sewer  
Pipe In @ 3 O'Clock

Infiltration: **None** Pipe Seal Cond: **Unknown**
